Methodology for Collecting and Processing Data to Diagnose the Technical Condition of a Building: A Case Study of the State Tax University in Irpin (Ukraine)

Nazarii Danyliv, Ihor Savchyn, Dmytro Serebrianskyi, Tom Austin

DOI: 10.14627/avn.2026.1.2

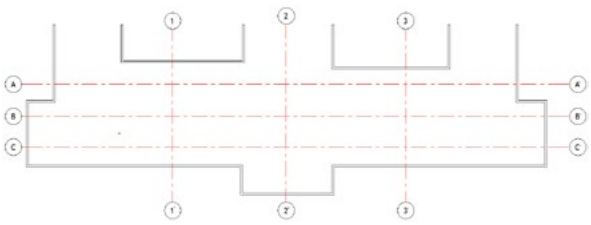
Fig. 4 | Scheme of the constructed sections (A, B and C: longitudinal sections; 1, 2 and 3: transverse sections)

The analysis was performed along three longitudinal and three transverse sections of the building, constructed based on the 3D point model. The scheme of the constructed sections is shown in *Fig. 4*.

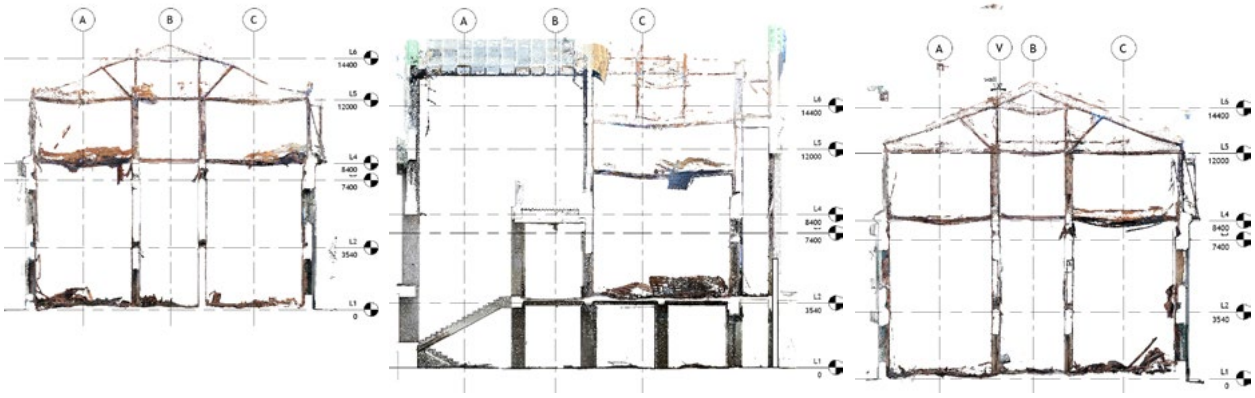
a) Transverse sections 1 – 1'

Analyzing transverse sections 1–1' (see *Fig. 5a*), it can be observed that at level L1, the floor was filled in and covered with debris

remnants resulting from the fire. At levels L2 and L3, the floors are completely absent, as the wooden structures that originally formed them were entirely destroyed by the fire. At levels L4 and L5, significant deformation of the metal beams, which served as the ceiling, was detected. Along the A-axis, the deformation reaches up to 240 mm at level L4 and up to 250 mm at level L5. Along the C-axis, the deformation reaches up to 150 mm at level L4 and up to 260 mm at level L5. Between levels L5 and L6, deformation of the metal roof frame and the collapse of the roof slab were recorded.

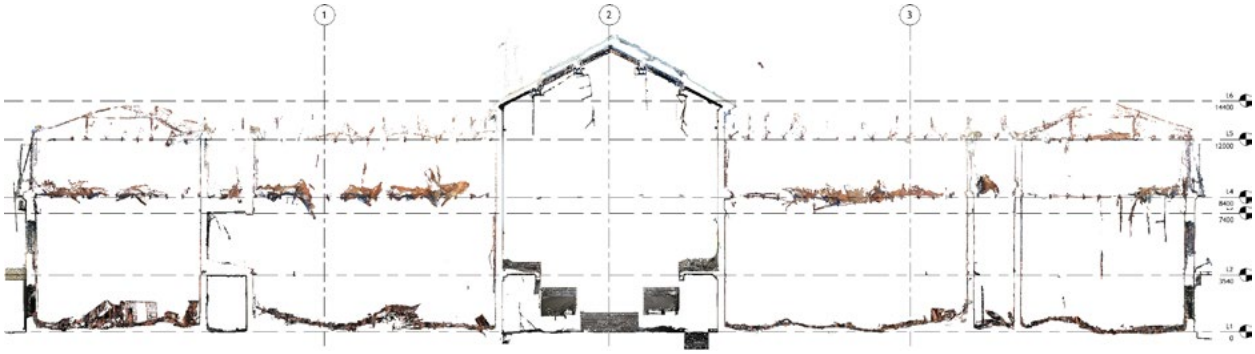
b) Transverse sections 2 – 2'

Analyzing cross-section 2–2' (see *Fig. 5b*), which was constructed in the central part of the university's main building, it can be noted that no damage was found at levels L1 and L2, as the floor structures at these levels are made of reinforced concrete, ensuring their resistance to high temperatures. Between levels L4 and L6, ceiling deformation was recorded, specifically the deflection of metal beams, which reaches up to 200 mm between levels L4 and L5 and up to 270 mm between levels L5 and L6, as well as partial deformation of the roof frame.

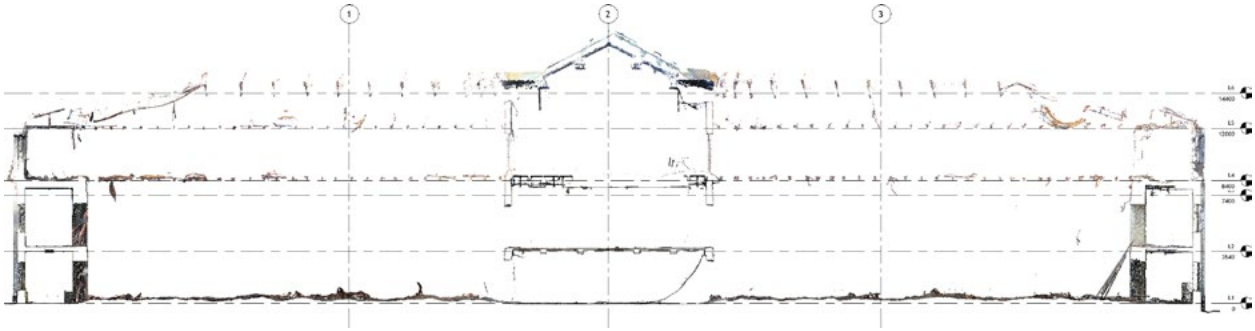
c) Transverse sections 3 – 3'

Analyzing cross-section 3–3' (see *Fig. 5c*), it can be observed that the main damage corresponds to that identified in cross-section 1–1' (see *Fig. 5a*). However, in addition, a tilt of the load-bearing wall between the A–A' and B–B' axes was detected. The 1° inclination of the wall towards the A-axis (equivalent to 122 mm at level L6) is likely caused by the collapse of the floor between the first and second floors, posing a serious risk to the structural stability of the building.

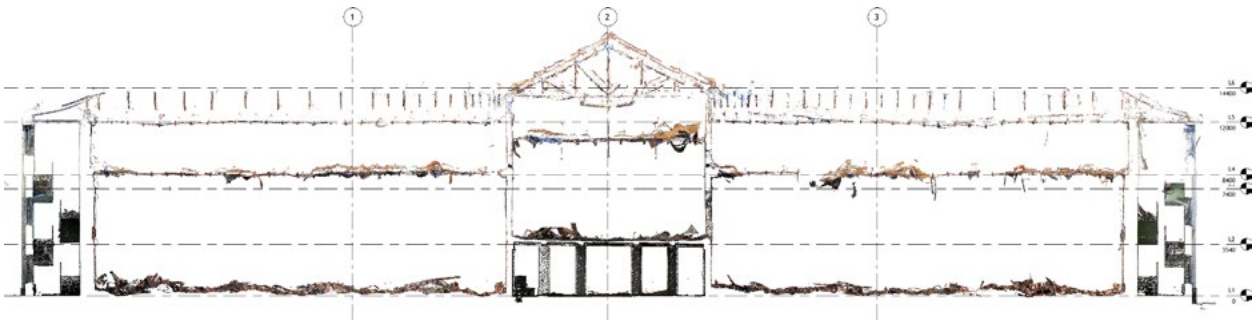
a) Longitudinal sections A – A'

Analyzing longitudinal section, A–A' (see *Fig. 6a*), significant damage is observed between levels L4 and L6. In particular, there is substantial deformation of the metal floor beams at level L4, with beam deflections reaching up to 250 mm, and at level L5, deflections reach up to 270 mm. Additionally, at level L4, a substantial quantity of metal roof slab remnants is present, along with roof frame deformation of up to 240 mm, which was likely caused by high temperatures during the fire. At levels L2 and L3, the floors were completely destroyed due to their wooden construction. However, in certain areas – to the left of axis 1–1' and to the right of axis 3–3' – the floors remained intact.

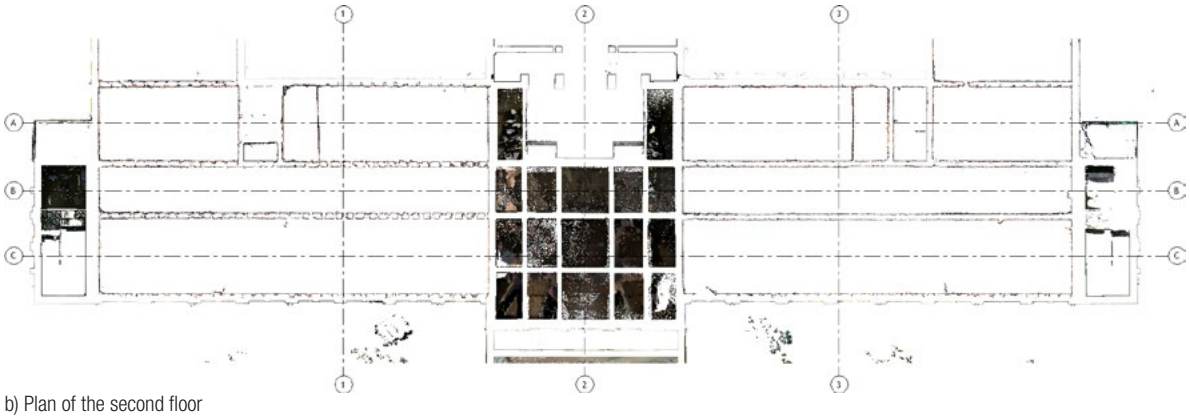
a) Ground floor plan

The ground floor plan of Level L1 (see *Fig. 7a*) shows partial infill with post-fire debris, primarily on the left and right sides of the building, corresponding to areas affected by the collapse of the upper structures. The floor structure at this level, predominantly made of reinforced concrete, remained largely intact due to its high fire resistance. However, damage to the wall along the B-axis was observed, resulting from the collapse of the ceiling.

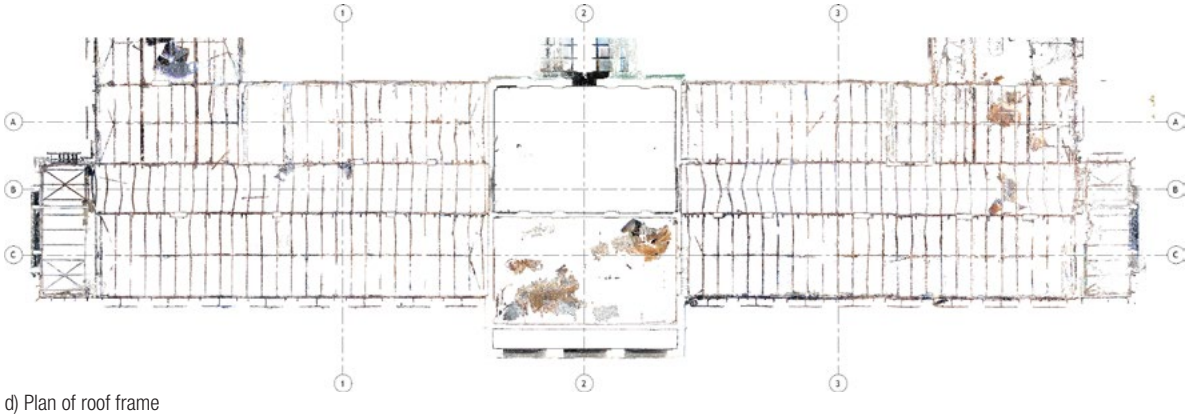
c) Plan of the third floor

Analyzing the floor plans at levels L1, L2, L3, and L5 (see *Fig. 7*), several structural characteristics and damage patterns can be identified:
